Transport
Canada

TP 185E
Issue 3/2005

AVIATION SAFETY LETTER

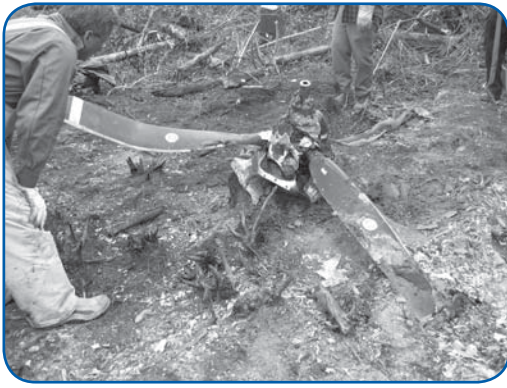
TSB investigator analysing the Cessna Caravan's propeller.

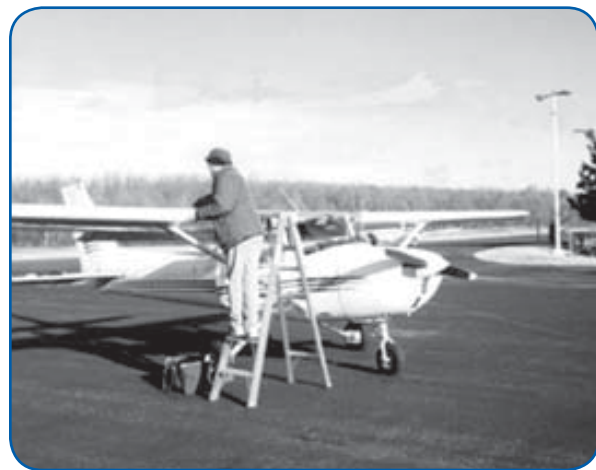
Pilot removing frost manually on small aircraft.
Photo: www.Cessna150-152.com.

Manual methods—Reducing the amount of de-icing fluid used can have a positive impact on both the cost and the environment. Manual methods of snow removal should be used whenever possible, as long as safety is not compromised. There are a wide variety of devices available to assist in the removal of frozen contaminants from aircraft. Factors such as temperature, amount of contamination, wind conditions, and contaminant location must be taken into account when choosing the method.

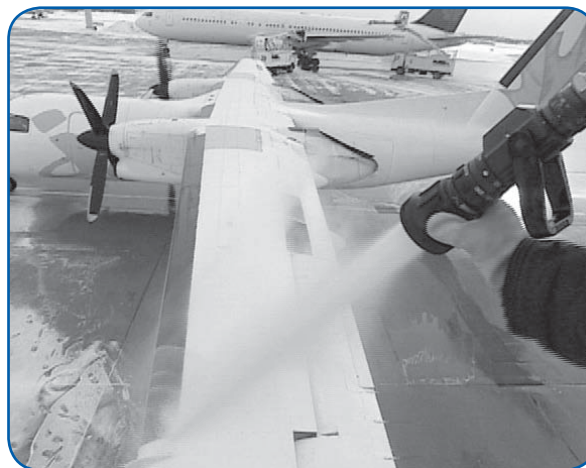
Action view from the cherry-picker's position.
